RATHBURN ARBORIST CONSULTING INC.

TREE RETENTION ASSESSMENT:

Civic address:	2700 West Broadway Vancouver BC
Report Date:	December 17, 2017; Updated March 5, 2018
Client name:	Beng Gunn, 2700 West Broadway Holdings Inc.
Date of site visit:	December 6, 2017
Weather during visit:	Dry and clear

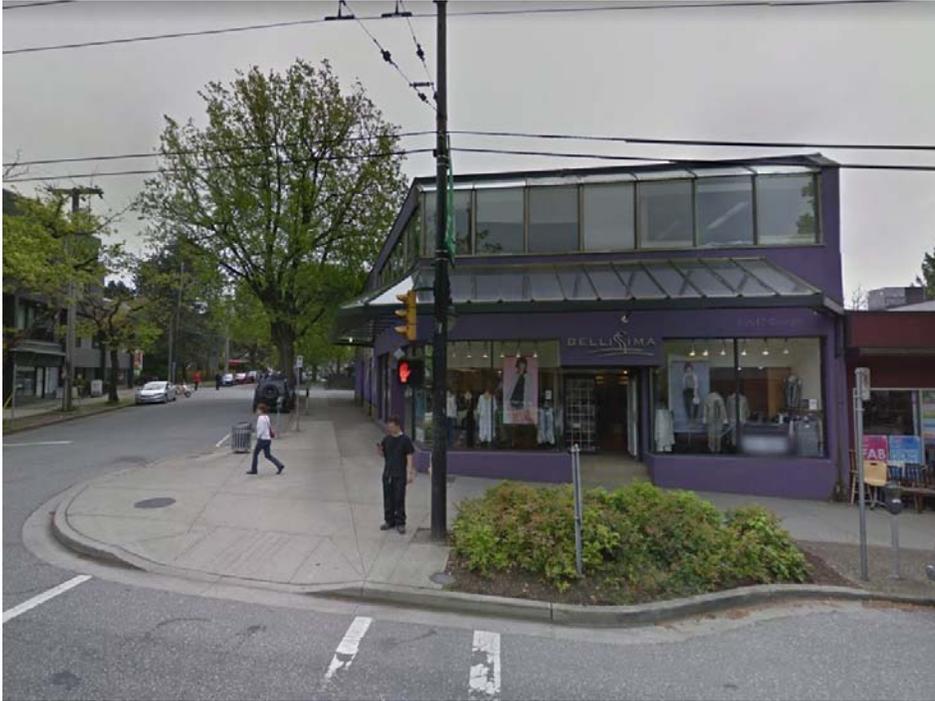
Photo 1: Looking at the subject site frontage.

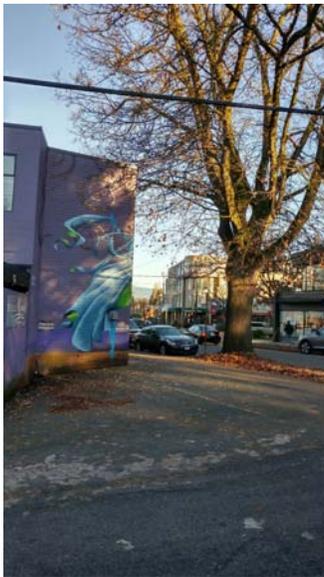
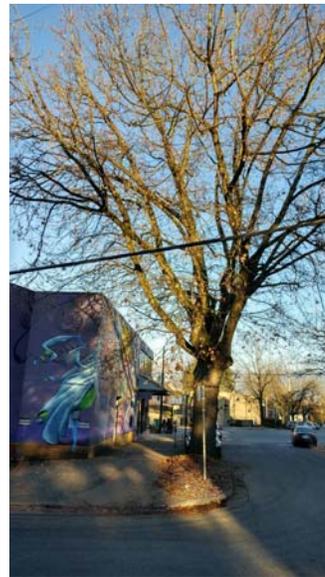
Photo 2 and 3 showing the subject City owned tree, east of the existing building.

Tag #	Common Name	Botanical Name	DBH ¹ (cm)	Dripline ²	Overall Condition	Comments	Retain/ Remove	Tree Retention Comments	TPZ
City-1	English oak	Quercus robur	96	7.5m	Normal	This tree is growing in a concrete cut-out between the road and the sidewalk. The tree is 4.25m from the existing building. The root zone has been restricted by the concrete sidewalk and existing building foundation. The tree's crown appears to have been previously pruned to reduce the encroachment over the property line.	Retain	This tree will require protection (fencing) however the concrete side and adjacent road covers the majority of root zone.	5.82 Modified to allow for road and sidewalk.

1. Pruning; the west side of the tree is growing slightly over the property line, and will require pruning to accommodate the new construction.
 - a) We have discussed the pruning with the Vancouver Board of Parks, and they have agreed to undertake the needed pruning. This pruning will be done by parks staff using their approved methods.
2. Existing building will be demolished under Project Arborist direction. Once the existing foundation is removed, the project arborist will inspect the subject trees root zone to determine if any root pruning is needed. The project arborist will undertake root pruning if needed.
3. Excavation for new foundation will be dug under on-site Project Arborist direction.

4. Any work to the sidewalk adjacent the tree must be approved by the Vancouver Board of Parks and be installed using low impact methods. Please note at this time, the plan shows the existing sidewalk to remain intact.
5. Tree Protection Fencing will be aligned to side walk cut out or specified by City

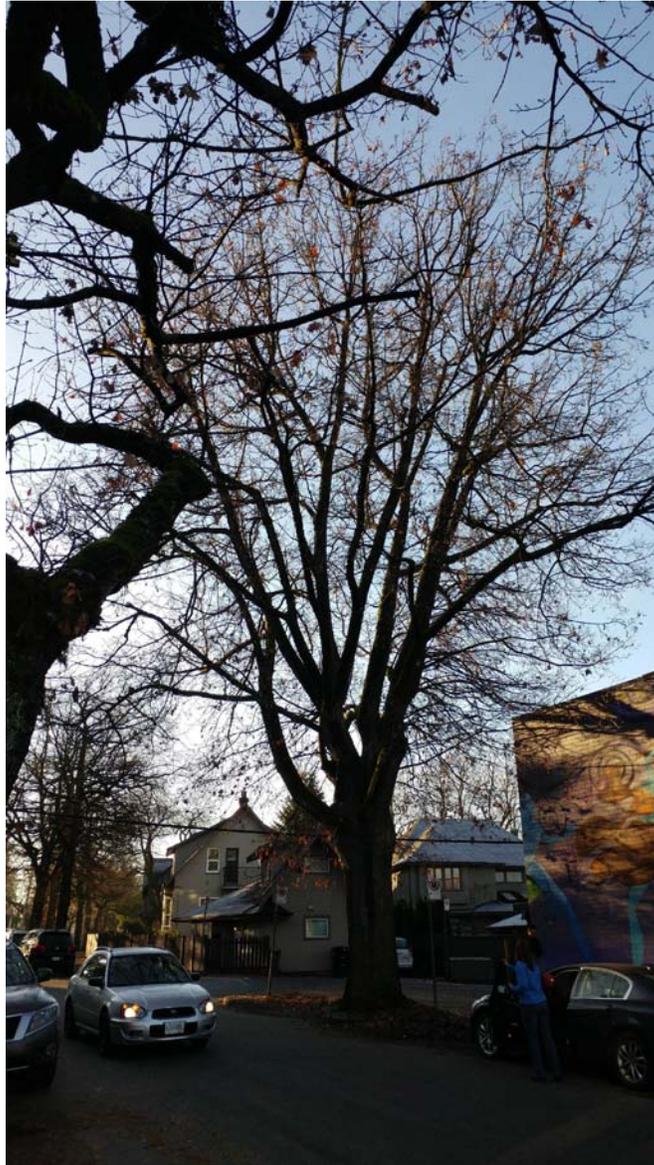
Photo 4: Looking at the subject City owned tree, showing that the side towards the existing building has been previously pruned to reduce the extent of the crow over the building.

Since this tree has been previously pruned in the past only minor pruning treatments are recommended (and to be undertaken by City Parks), to mitigate encroachment on the building, and we can provide detailed pruning specifications if requested. Any new hardscaping or sidewalk renovation must be done under project arborist (at City Parks discretion) supervision.
